New Hampshire Volunteer Lake Assessment Program

2003 Biennial Report for Pawtuckaway Lake Nottingham

NHDES
Water Division
Watershed Management Bureau
29 Hazen Drive
Concord, NH 03301

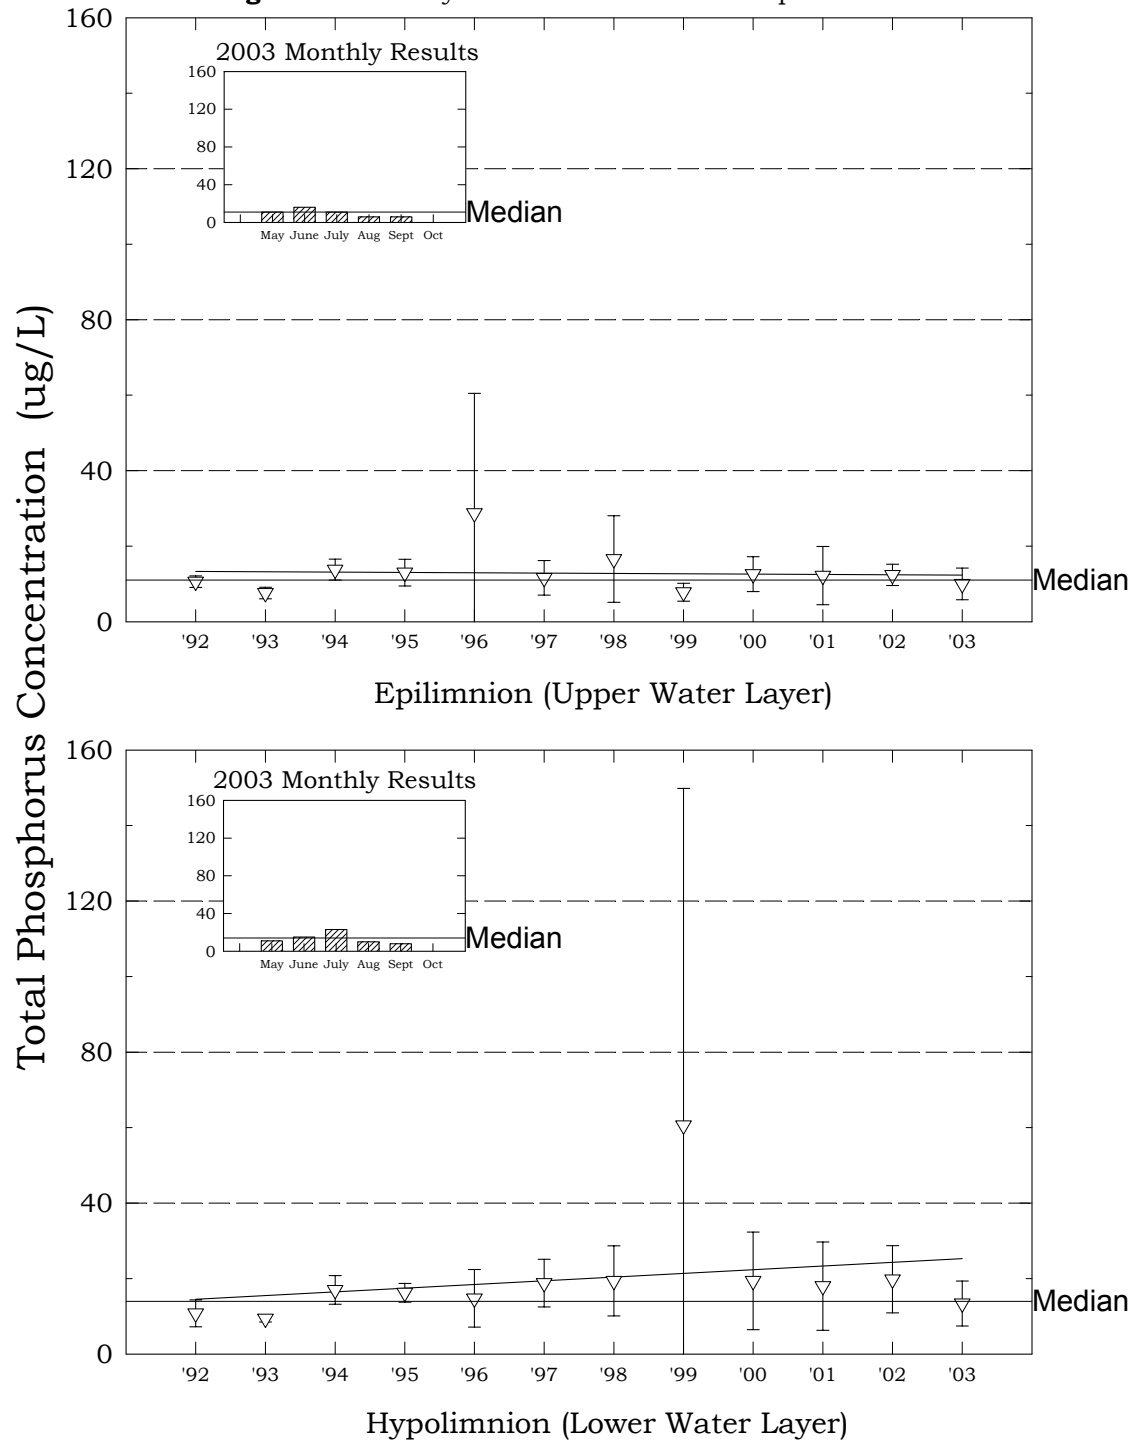
Figure 3. Monthly and Historical Total Phosphorus Data.

The current year data for the epilimnion (the top inset graph) show that the phosphorus concentration **increased** from May to June, **decreased** from June to September, and then **remained stable** from August to September. The phosphorus concentration in May, June, and July was either **equal to** or **greater than** the state median.

The current year data for the hypolimnion (the bottom inset graph) show that the phosphorus concentration **increased consistently** from May to July, **decreased** from July to August, and then remained **approximately stable** from August to September. The phosphorus concentration in June and July was **equal to** or **greater than** the state median. In August and September the total phosphorus concentration was **less than** the state median.

The historical data show that the 2003 mean epilimnetic and hypolimnetic phosphorus concentration is **approximately equal to** the state median.

Overall, the statistical analysis of the historical data show that the phosphorus concentration in the epilimnion (upper layer) and the hypolimnion (lower layer) has **not significantly changed** (either **increased** or **decreased**) since monitoring began. Specifically, the

phosphorus concentration in the epilimnion and hypolimnion has **fluctuated**, but has not *continually increased* or *continually decreased* since monitoring began in 1992.

- **Figure 3 and Table 8:** The graphs in Figure 3 (Appendix A) show the amounts of phosphorus in the epilimnion (the upper layer) and the hypolimnion (the lower layer); the inset graphs show current year data. Table 8 (Appendix B) lists the annual maximum, minimum, and median concentration for each deep spot layer and each tributary since the lake/pond has joined the program.
